Maintenance of Structural Components in Higher Risk* Buildings

An Owner's Best Practice Guide

Maintenance of Structural Components in *Higher Risk Buildings - An Owner's Best Practice Guide

The City of Calgary

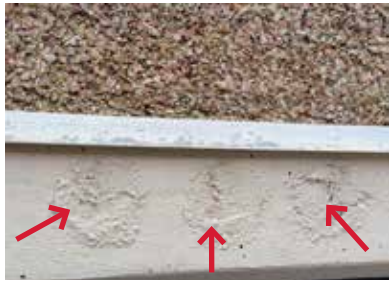
Indicators Of Post-Tensioned Structures	
Live End Anchor Pockets	
<p>At exposed post-tensioned slab edges, it may be possible to see the “live end” anchor pockets, which are the points the strands were originally stressed from. Typically these are circular in profile and filled with grout. However many slab edges are concealed by finishes such as cladding or flashing, and may not be visible. Below-grade slab edges will not be exposed.</p>

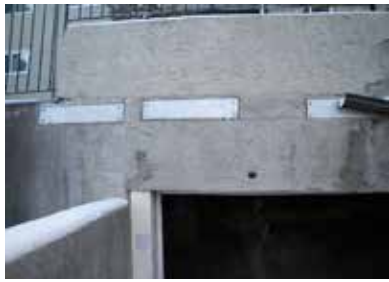
Eruption Plates	
<p>In some cases, exposed slab edges may be equipped with eruption plates, also known as restraint plates, which are installed as a precaution against strand eruption from the slab edges in the event of a break or sudden tension loss. These will generally be galvanized steel plates equipped with concrete anchors to secure the plate to the slab edge. Typically they are located at slab edges at or near ground level where pedestrians may be present. They are not common at upper floor levels, or where the slab edge is concealed by cladding or other finishes.</p>

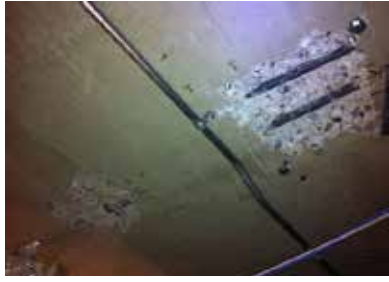
Staples	
<p>For slabs that are exposed at their underside (not concealed by ceiling finishes), such as parking slabs or in back of house areas (mechanical rooms, electrical rooms, storage areas), it may be possible to see evidence of post-tensioning by looking for staples. Staples are used to secure the post-tensioned strand chairs to the formwork during original construction. When the formwork is removed, the legs of the staples project out of the concrete.</p> <p>Note: the two post-tensioned strands are visible at upper right side of photo (black plastic sheathing), exposed as part of an investigation</p>

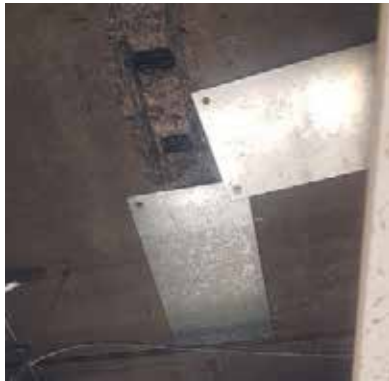
Inspection Recess Plates	
<p>Maybe the most common evidence of post-tensioning Owners can look for are inspection recess plates. When a building is assessed by an Engineering Professional, inspection recesses are usually chipped into the slab to expose short lengths of strands at different locations throughout the structure. The recesses allow the strands exposed within to be visually inspected and tested for tension, and re-accessed for future testing. The recesses are typically chipped at the underside of the slab where the strands are closest to the surface. After inspection, the recess cavity is filled with a mineral wool insulation and the recesses covered with an eruption plate, usually a square or rectangular galvanized steel plate. The plate is equipped with concrete anchors to secure the plate to the underside of the slab. These plates may not be visible at slabs concealed by ceiling finishes, but can usually be found in parkades or in back of house areas where the slabs are exposed.</p>

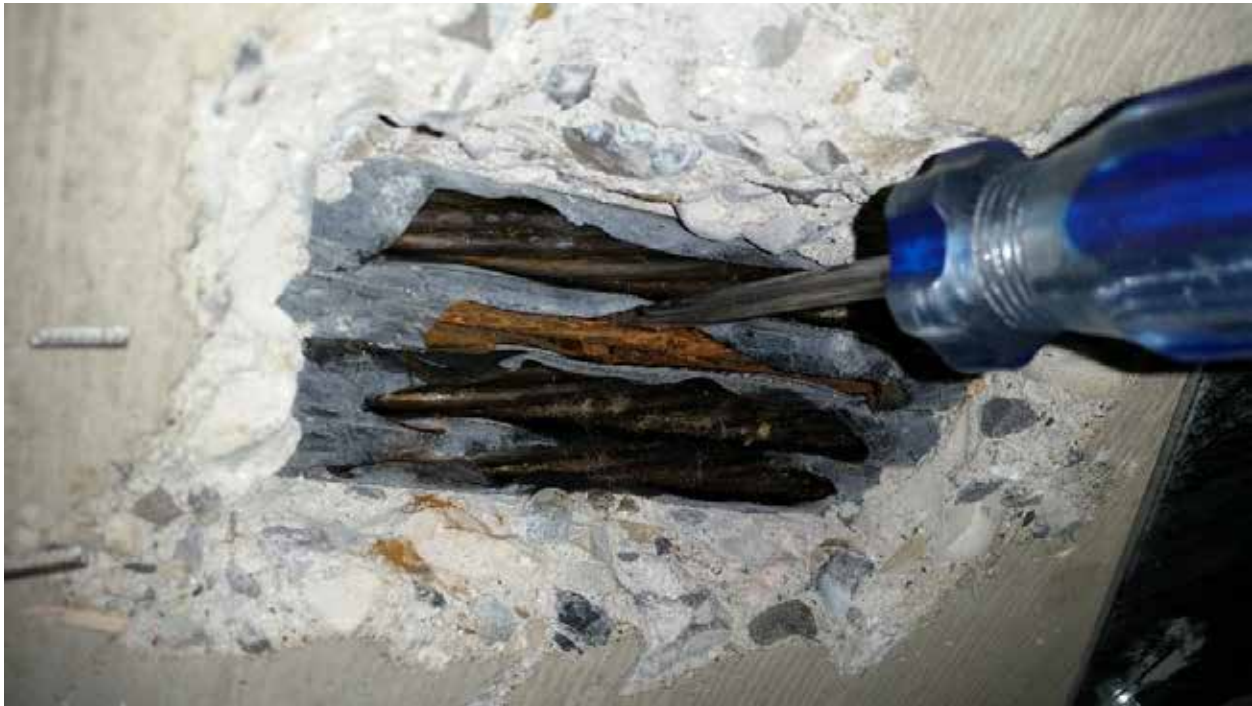
***NOTE:** Penetration test showing screwdriver wedged between wires of a post-tensioned strand. Note corrosion visible at the affected strand.

Where deemed applicable by the Engineering Professional, removal and full-length inspection of strands can yield additional information regarding the extent of moisture present in the system and the degree of strand corrosion. Moisture exposure at anchorages or at other locations along the strand length may not be detected at inspection recesses. It is also not possible to chip inspection recesses within the highly compressed anchor zone concrete, and therefore removal and inspection of strands may be the only means to identify if corrosion is occurring at the anchors. Usually only fully tension deficient (failed) strands are selected for extraction.

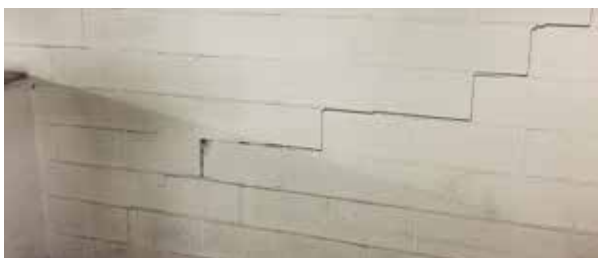
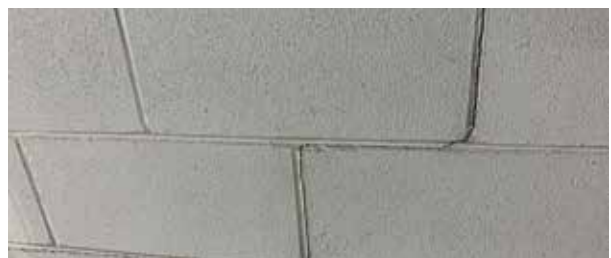
Step Cracking (in masonry walls)

Step Cracking: Mortar cracks which appear in the shape of stair steps.
