BOW RIVER

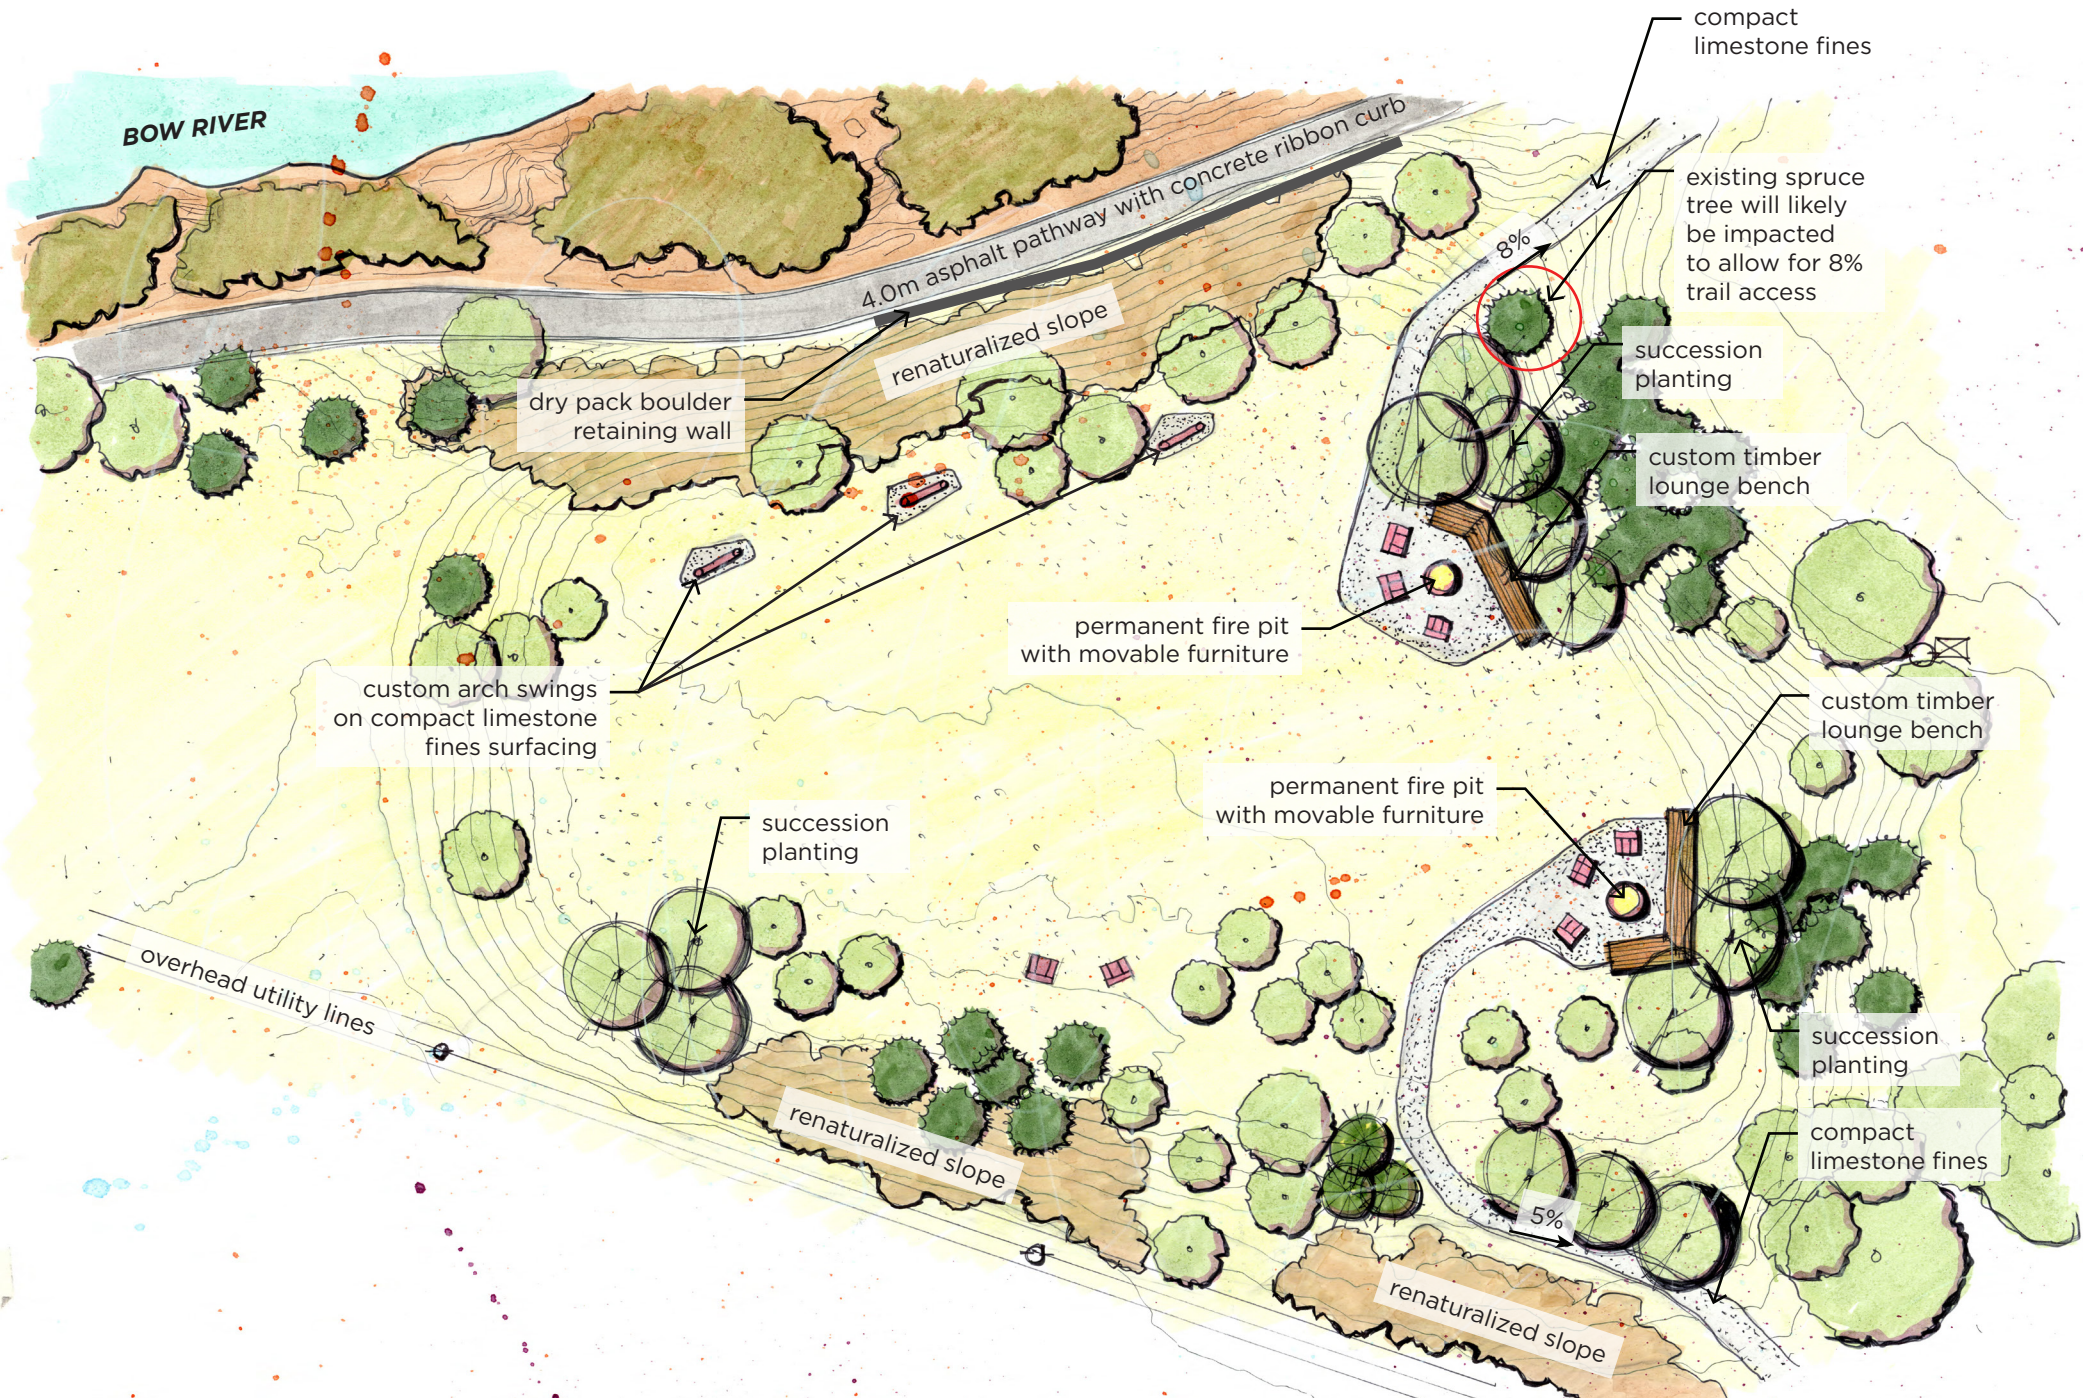
4.0m asphalt pathway with concrete ribbon curb

compact limestone fines

existing spruce tree will likely be impacted to allow for 8% trail access

dry pack boulder retaining wall

custom timber lounge bench

permanent fire pit with movable furniture

custom arch swings on compact limestone fines surfacing

overhead utility lines
